Problem

Tectyl proposed approach

Solution

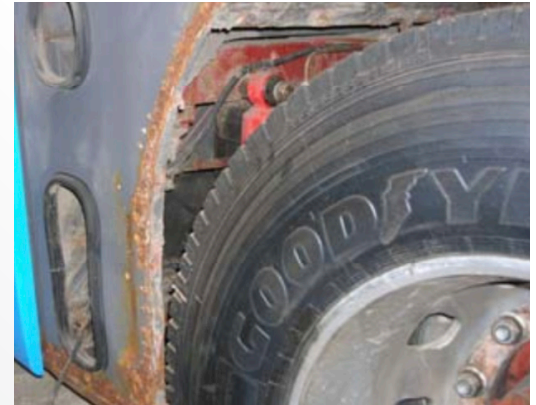
Public transport operators across Europe face a recurring and costly challenge: premature corrosion of exposed metal components on buses, even when vehicles are relatively new. This issue is particularly evident in wheel arches, underbody structures, seams, and joints where factory-applied protection is insufficient or uneven.

Operating environments accelerate the problem. Road salt, moisture, stone chipping, sand, and debris continuously attack vulnerable areas. Once factory primers or thin underbody coatings are breached, corrosion initiates rapidly and spreads beneath coatings, often remaining invisible until structural damage becomes evident.

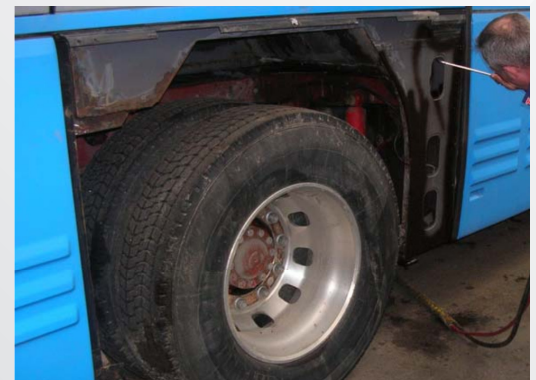
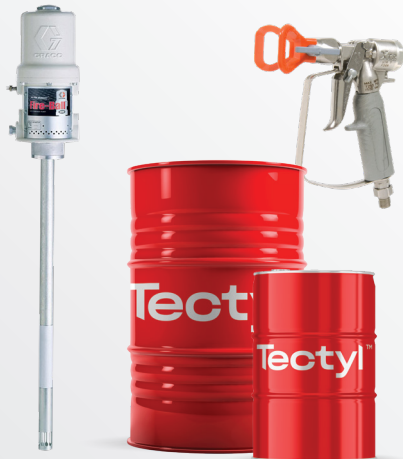
Tectyl 558 AMC is applied as the first layer at approximately 150 microns dry film thickness.

- ▶ Penetrates micro-crevices and seams
- ▶ Actively inhibits corrosion on bare or lightly oxidized metal
- ▶ Seals vulnerable areas and prevents moisture ingress

Preventive corrosion protection system for new and nearly new buses. Tectyl's recommended solution is a **two-layer corrosion protection system**, optimized for wheel arches, underbody components, and other corrosion-prone zones.

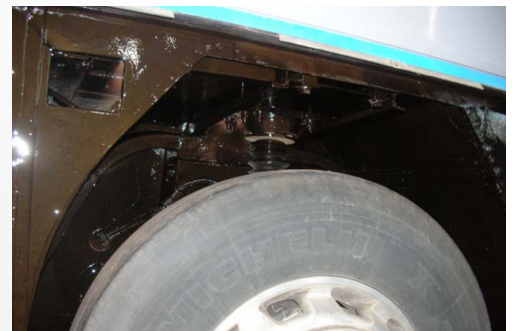
For consistent quality and controlled film thickness, Tectyl recommends professional airless application systems, such as:

- ▶ High-pressure pump systems with appropriate spray guns and nozzles
- ▶ Application parameters tailored to vehicle geometry and target areas
This ensures uniform coverage and repeatable results across entire fleets.

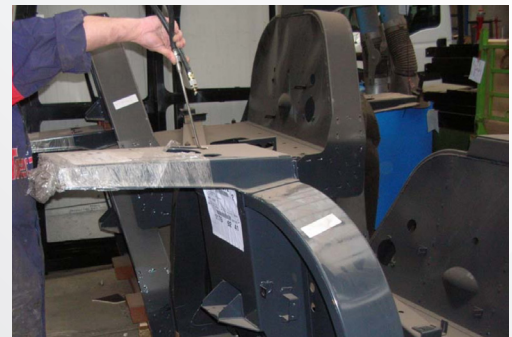
- ▶ Visual inspections every two years
- ▶ Localized repair or re-application after mechanical damage or structural repairs
- ▶ Integration of corrosion checks into standard maintenance schedules.
