Problem

Tectyl proposed approach

Solution

Two-layer chassis protection system

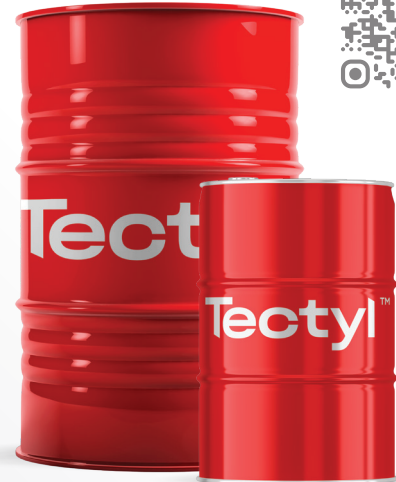
Tectyl™ 558 AMC

The penetrating properties of **Tectyl 558 AMC** ensure effective protection of seams, welds, and complex geometries on chassis structures. The product stabilizes surface conditions and improves adhesion of the protective top layer.

- ▶ **Tectyl 558 AMC** applied as a penetrating corrosion protection layer
- ▶ **Tectyl 120** applied as a high-build underbody protective coating

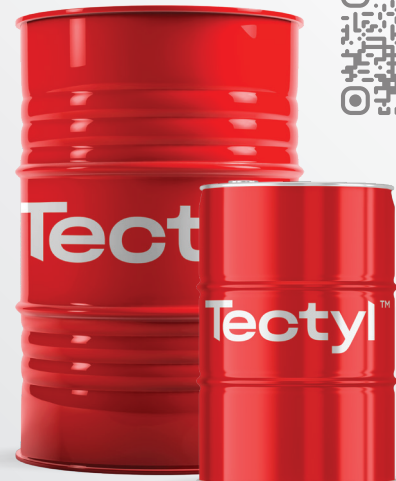
Tectyl™ 120

Tectyl 120 forms a thick, durable coating that protects the chassis against mechanical abrasion, stone chipping, and long-term exposure to moisture and road salt.
